## PROJECT CASE STUDY Freightliner Inspection Pits

A leading Mechanical and Electrical consultant asked **Kellwood** to provide an **inspection pit lighting solution**, this time for a new **Freightliner** maintenance site in the south-east of England.

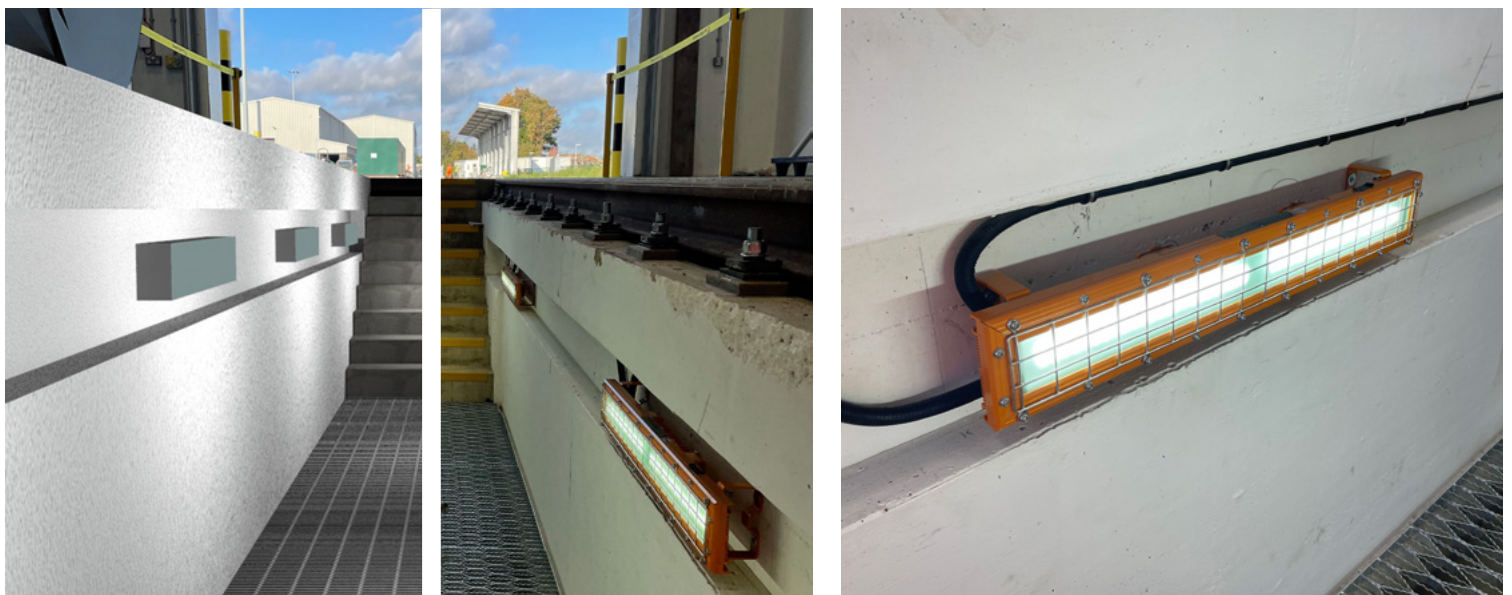
Kellwood modelled the inspection pits and carried out lighting designs. Multiple calculation surfaces were included to assess vertical illuminance at floor level, and at a typical working height.

Kellwood’s optimised LED solution used low-energy **Stephenson Series** hazardous area linear lights. They could deliver the necessary lumen package to meet specification targets:

Minimum	Target	Design Achieved
Average Lux	>300	>500	>530
Uniformity	>0.4	>0.4	>0.43

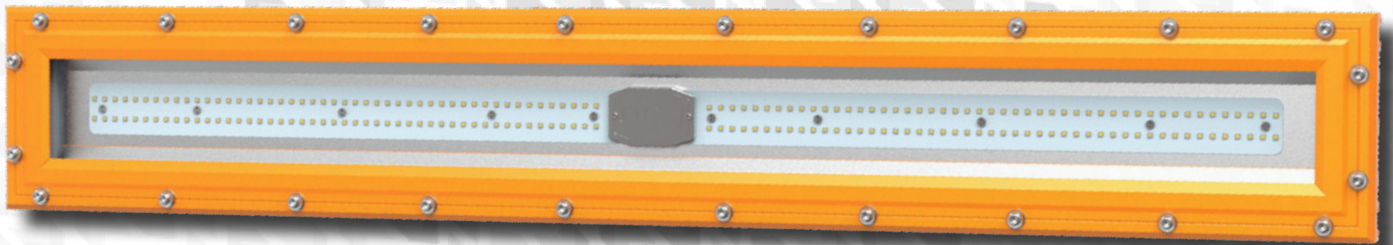
The Zone 1 certified Stephenson Series is suitable for installation in this potentially explosive atmosphere, helping to keep staff safe.

Lights could accommodate wire-in-wire-out installation. This removed the requirement for additional ATEX junction boxes and reduced overall costs

An integrated 3-hour emergency option was supplied to ensure compliance with escape-route requirements. This simple emergency solution was cheaper to install than a non-maintained emergency lighting option.
